The fire resistance performance of a specimen of a symmetrical, non-loadbearing, partition wall assembly tested in accordance with BS 476: Part 22: 1987, Clause 5

431114/R

**STS Ltd**

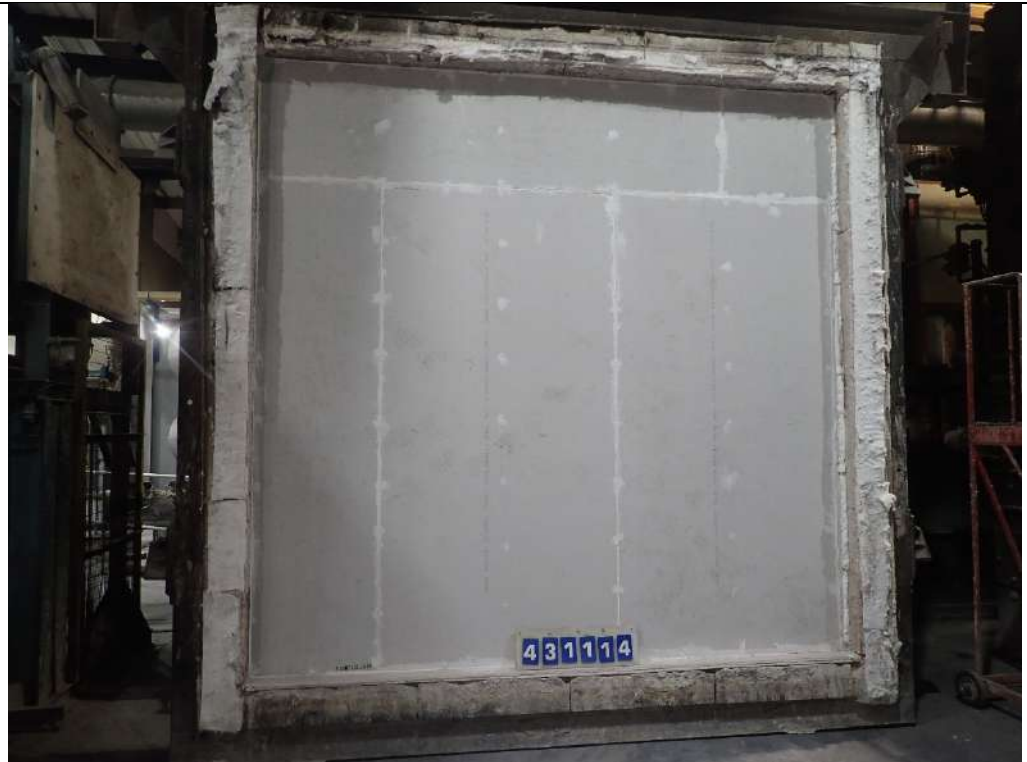
The exposed face of the test specimen prior to testing

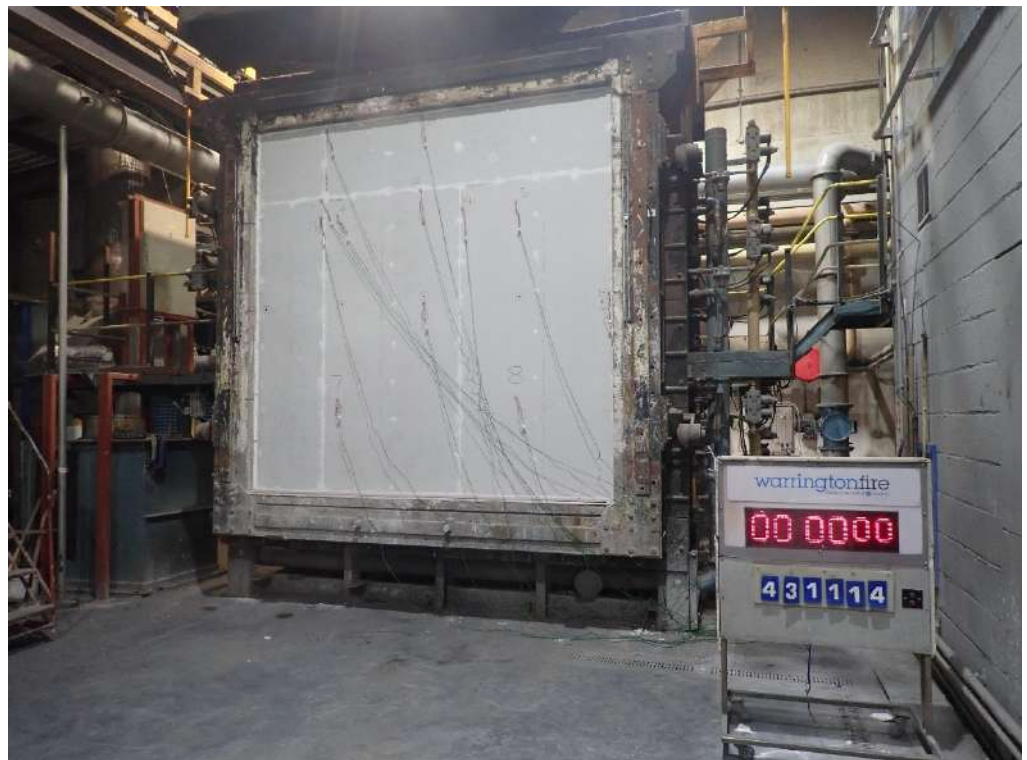
The unexposed face of the test specimen prior to testing

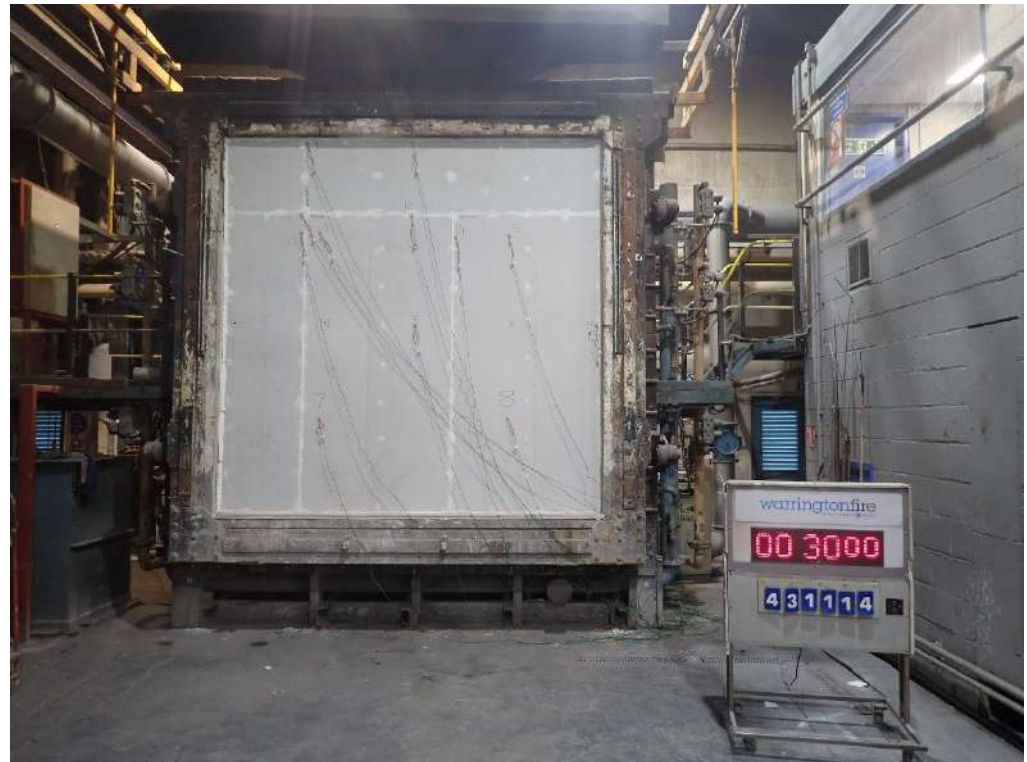
The unexposed face of the test specimen after 30 minutes of testing

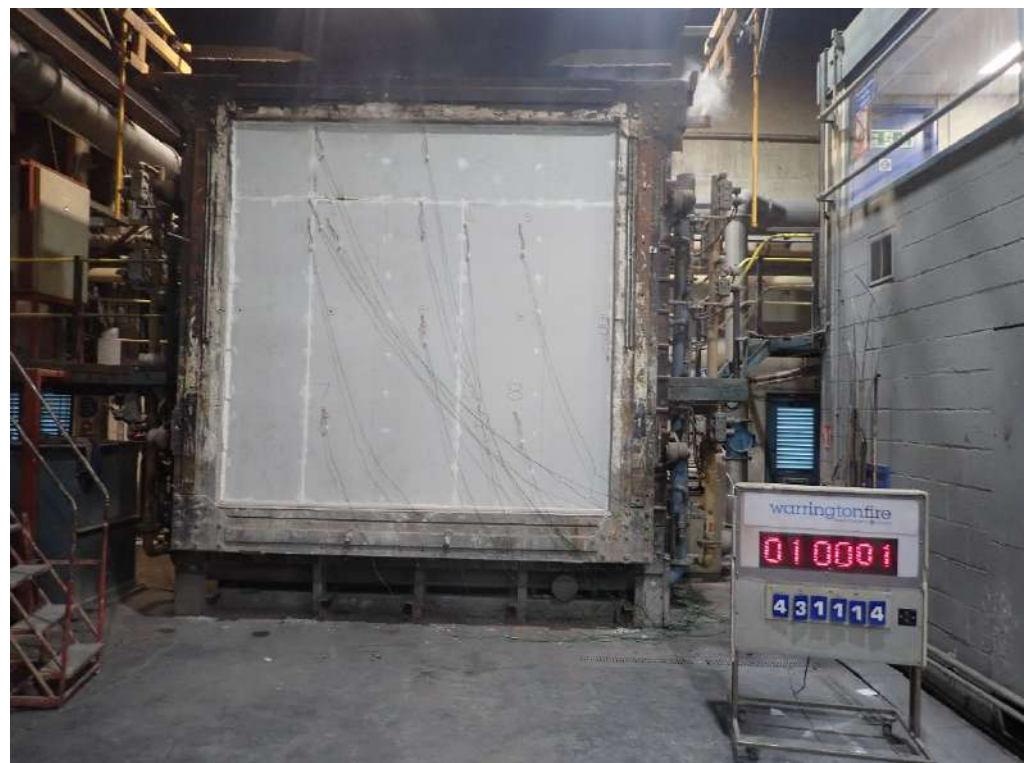
The unexposed face of the test specimen after 60 minutes of testing

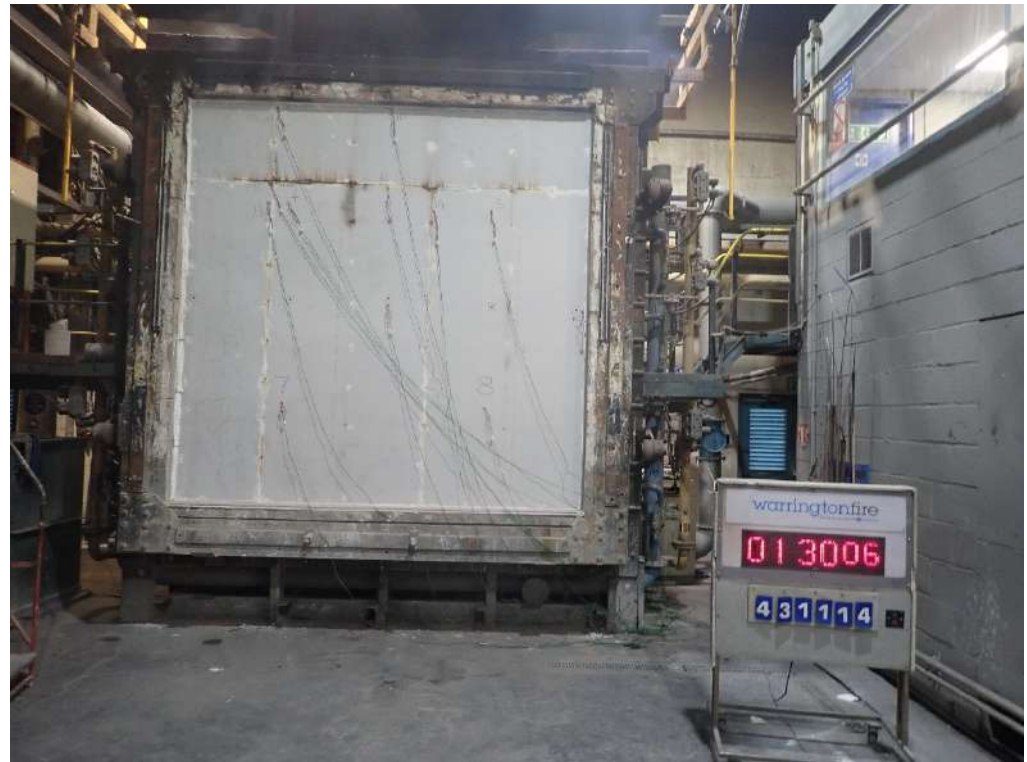
The unexposed face of the test specimen after 90 minutes of testing

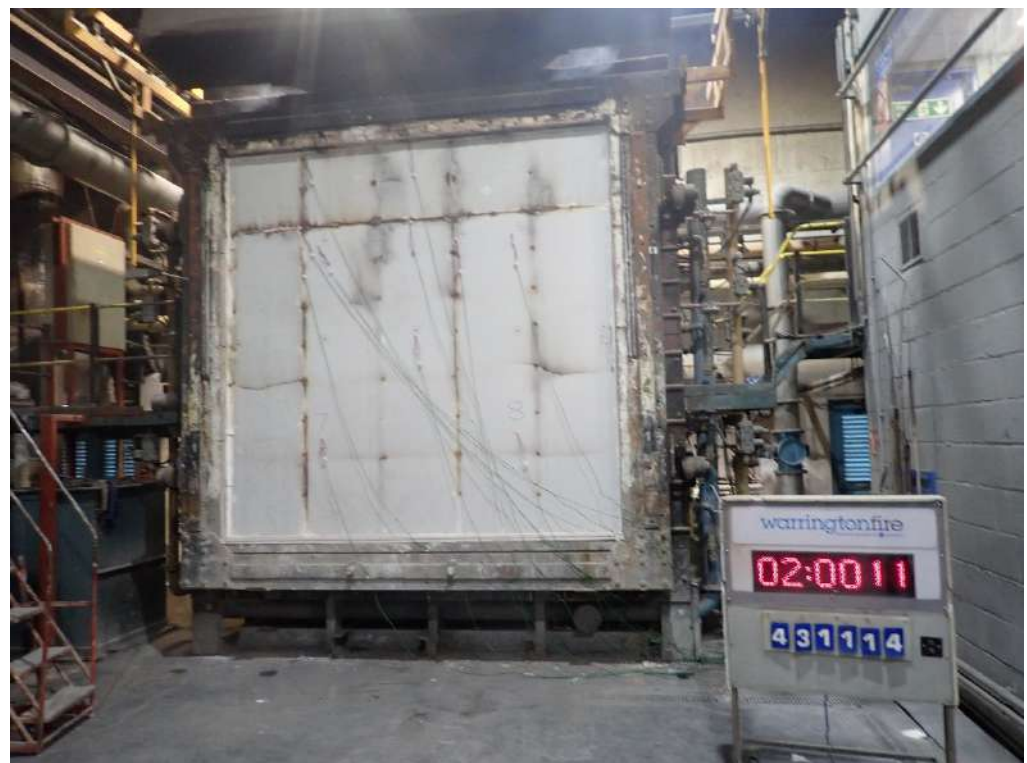
The unexposed face of the test specimen after 120 minutes of testing

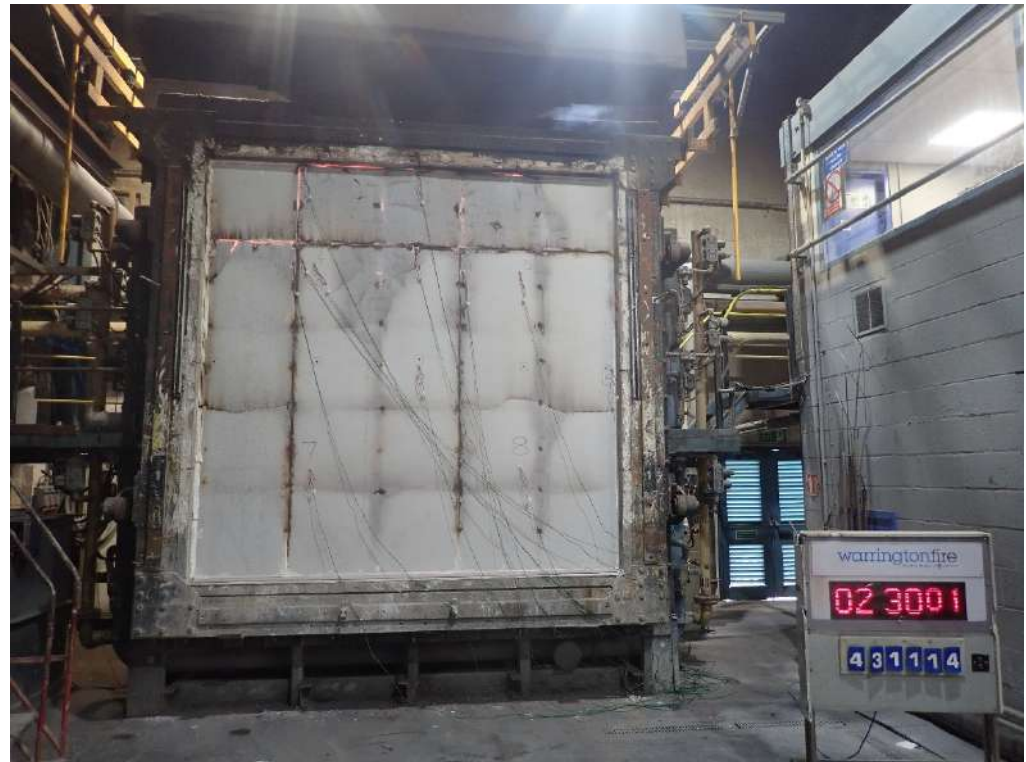
The unexposed face of the test specimen after 150 minutes of testing

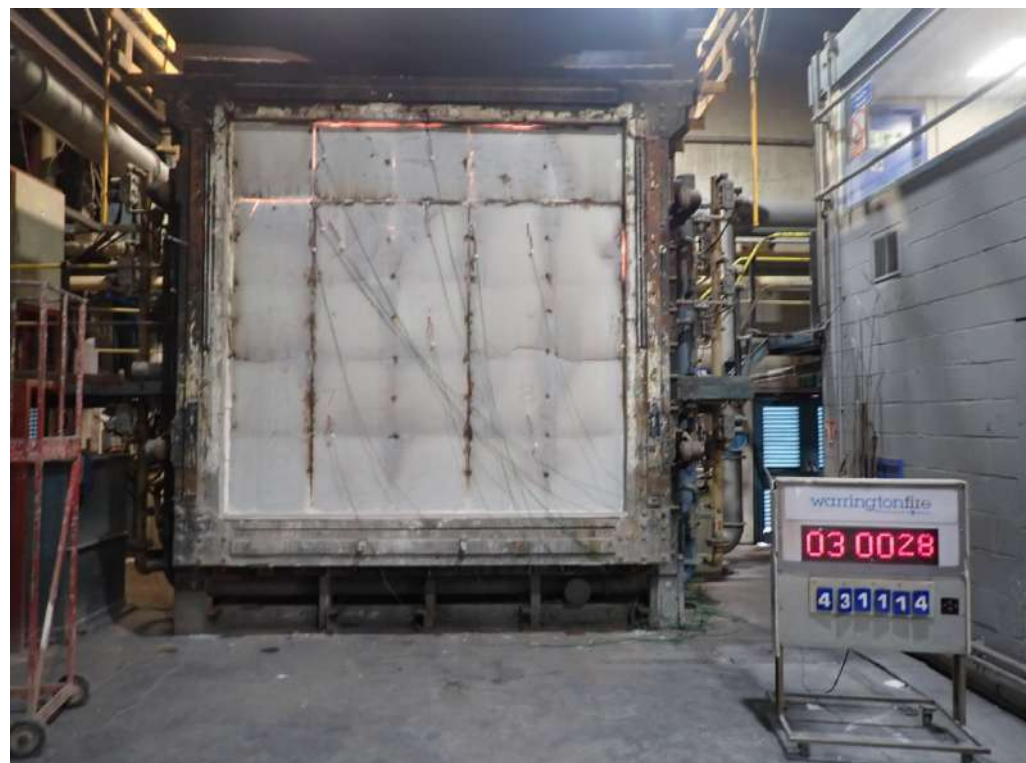
The unexposed face of the test specimen after 180 minutes of testing

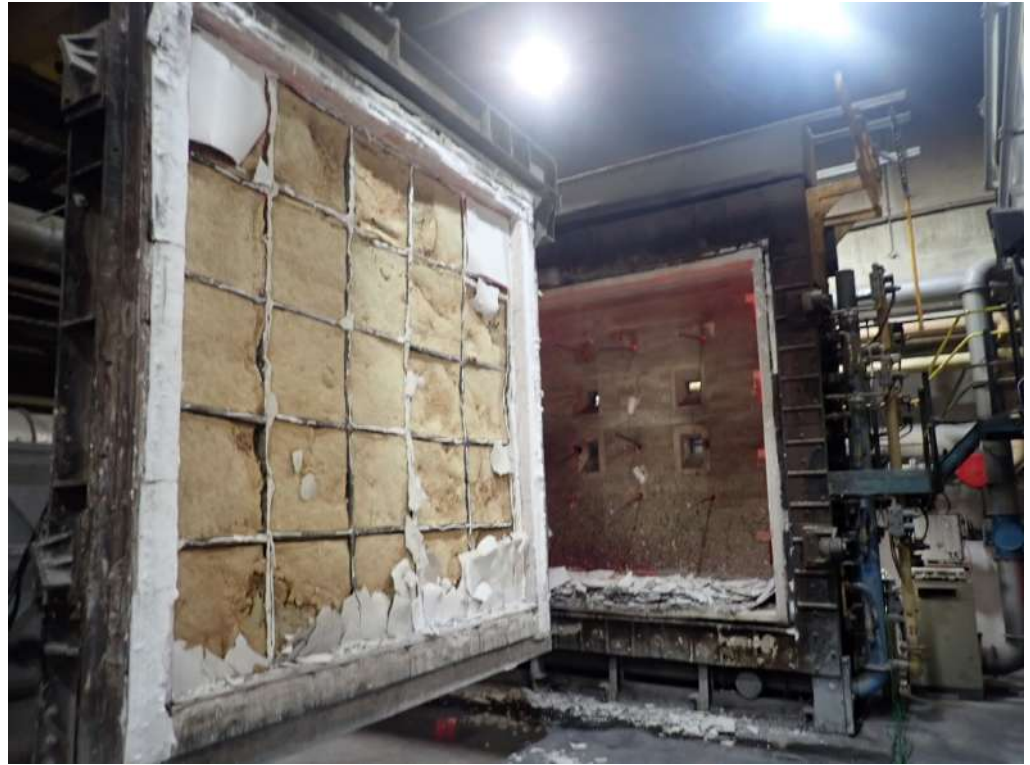
The exposed face  
of the test  
specimen  
immediately after  
the test

| Time | | All observations are from the unexposed face unless noted otherwise. |
|---|---|---|
| 32 | 00 | The board on the exposed face is glowing bright red, the broken layers of board are slipping down. In some places complete sections of board are falling away and exposing the insulation. |
| 32 | 00 | Most of the central board on the exposed face has fallen exposing the insulation and framework. |
| 67 | 00 | The horizontal section of board has now fallen from the exposed face. |
