Garnica **Fireshield Building** Plywood is modified by a fireproof treatment that provides the entire panel exceptionally fire resistant. Specially designed for indoor use.

## FIRESHIELD – Face veneer quality B

## FIRESHIELD – Face veneer quality BBA

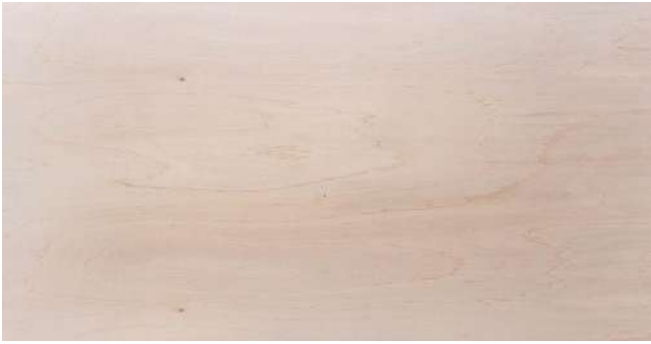
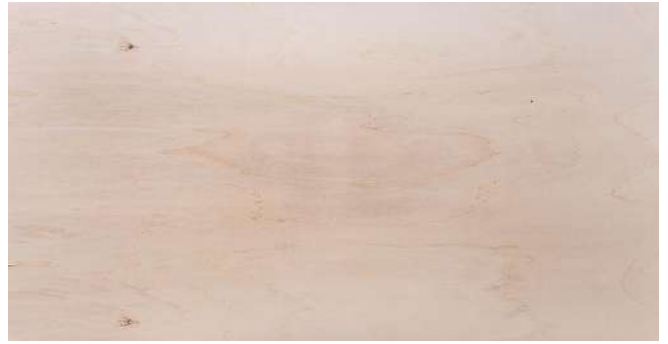
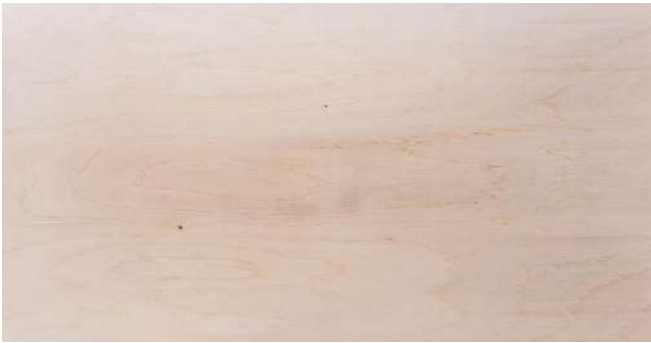
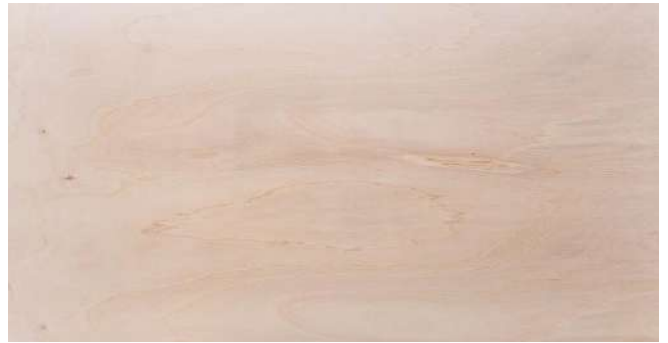
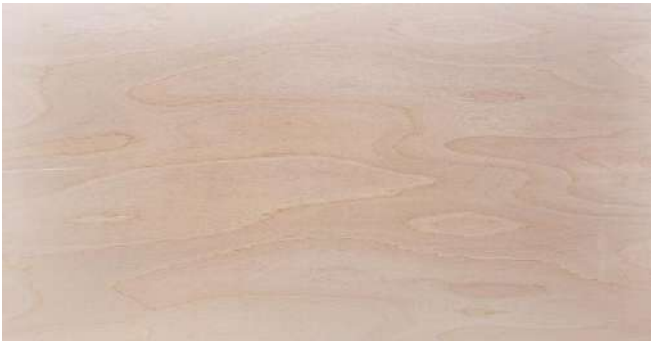
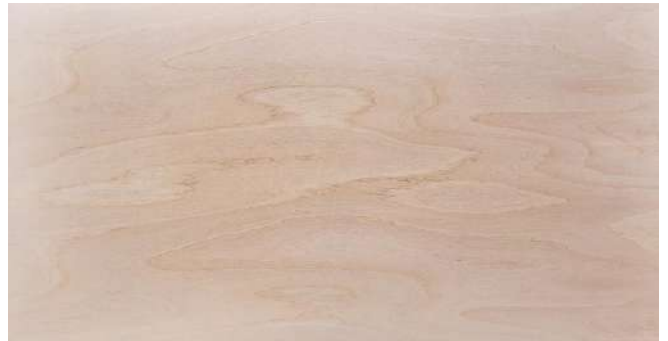
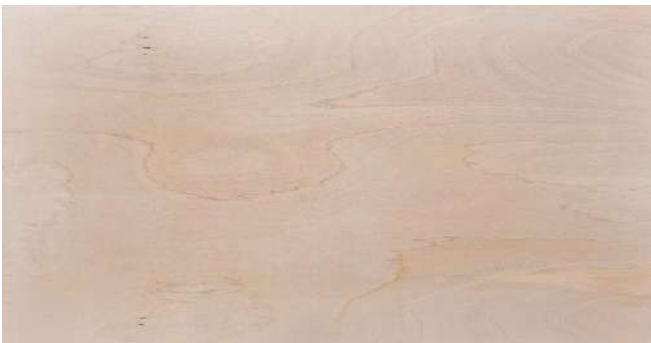
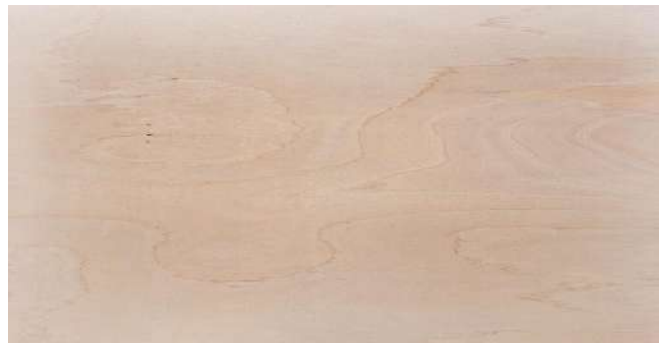
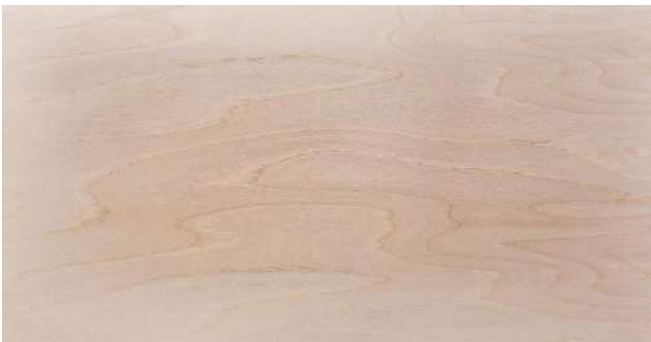
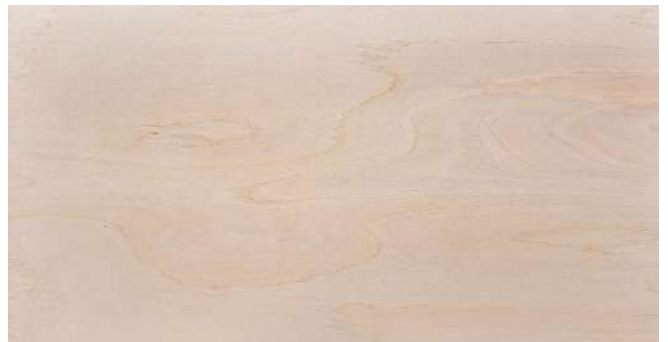
The fire-retardant treatment process may alter and highlight the natural patterns of poplar. In this grade, more pronounced grain and greyish veining may be observed, making it suitable for decorative applications.

*This photos are intended to show the natural variability of the Wood within the same Quality grade, in the batches photographed. The different Quality grades have a wide range of admissible defects; consequently, these photos do not imply any guarantee from Garnica that they are representative of other batches. They are simply examples of what might be found in each Quality grade.*

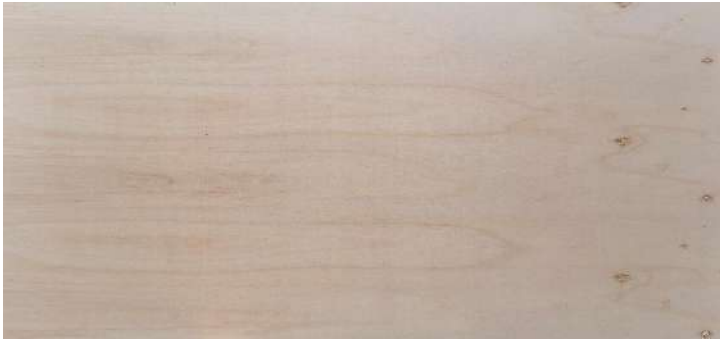
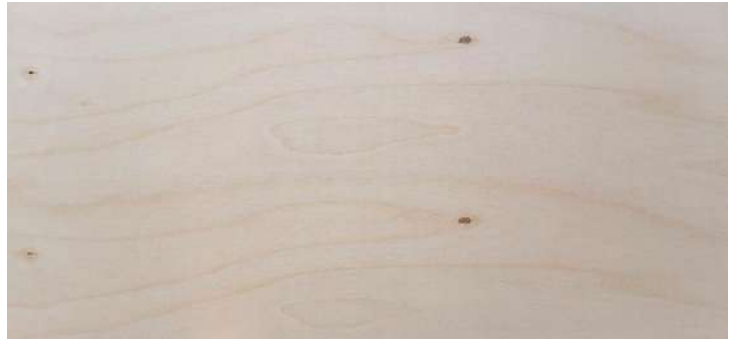
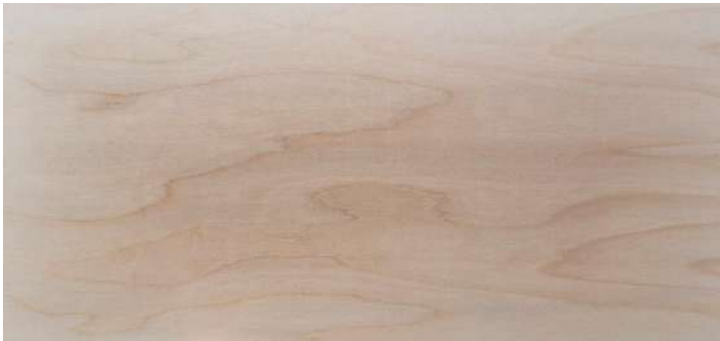
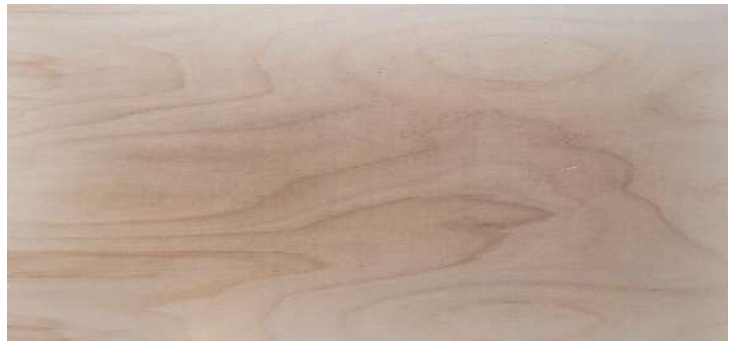
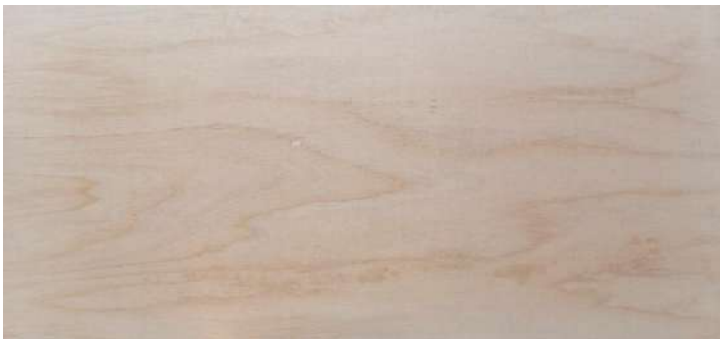
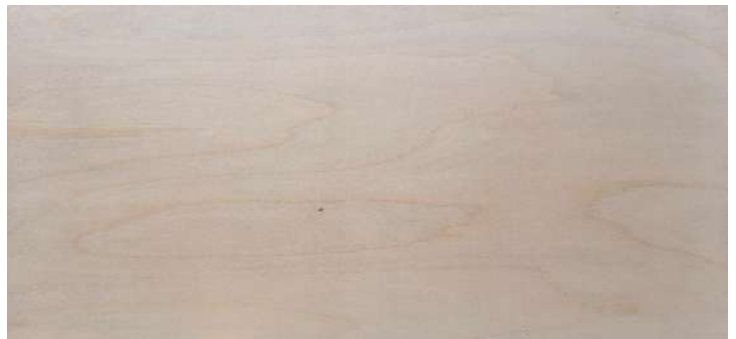
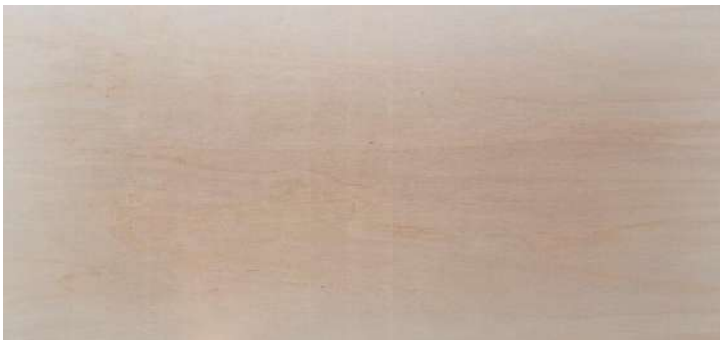
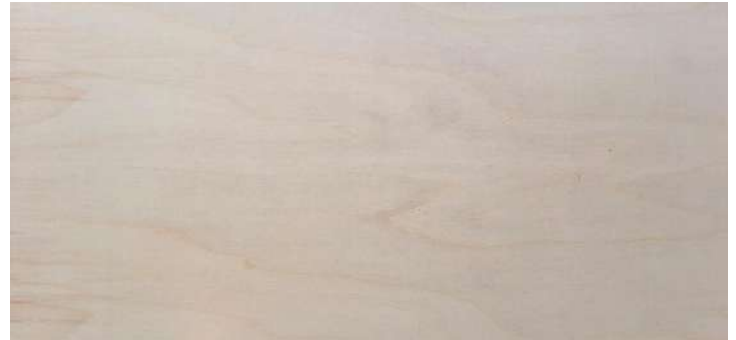
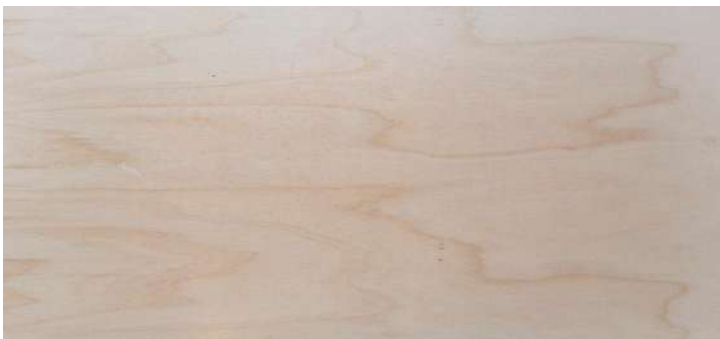
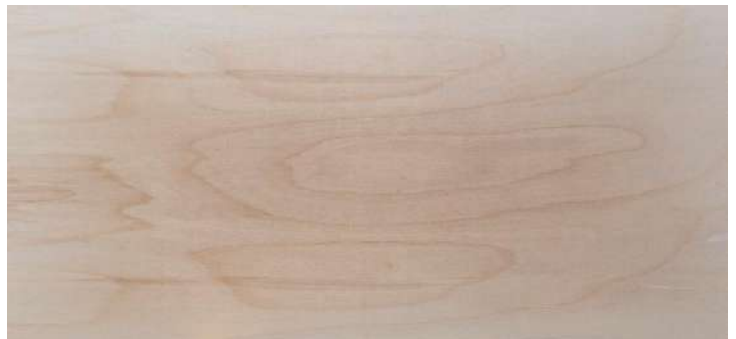
The fire-retardant treatment process may alter and highlight the natural patterns of poplar. In this grade, surface darkening and heterogeneity may be observed; therefore, its use in visible applications is not recommended.

*This photos are intended to show the natural variability of the Wood within the same Quality grade, in the batches photographed. The different Quality grades have a wide range of admissible defects; consequently, these photos do not imply any guarantee from Garnica that they are representative of other batches. They are simply examples of what might be found in each Quality grade.*
